Manhole Inspection Summary

Manhole # S37CC1002MH

Location Address: **621 37TH ST**

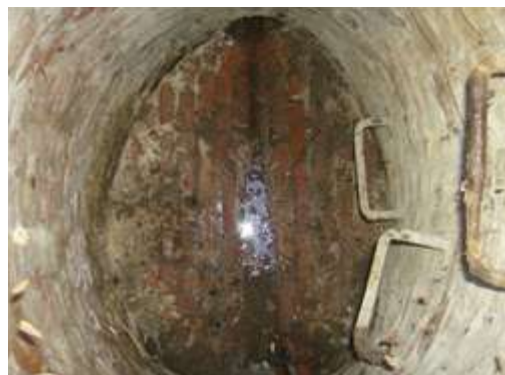
Top View

Corroded steps. Channel debris.

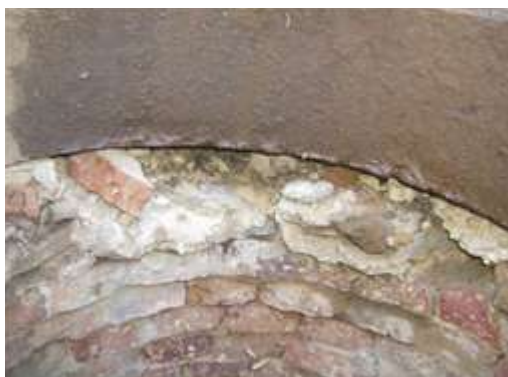
Defect

Frame leaks. Frame offset. Adjustment deterioration, loose brick and infiltration.

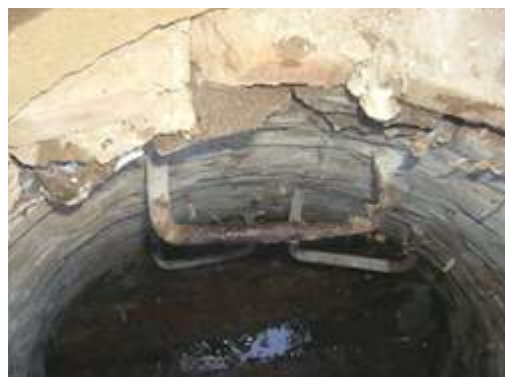
Defect

Frame leaks. Frame offset. Adjustment deterioration, loose brick and infiltration - other side.

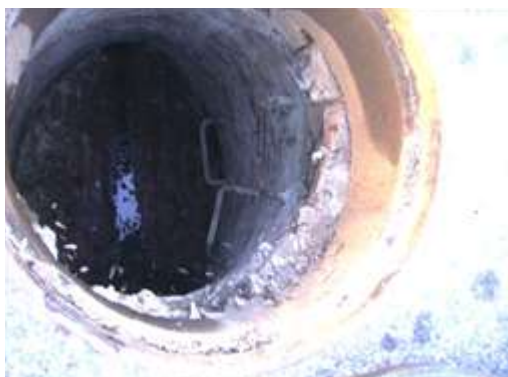
Defect

Frame leaks. Frame offset. Adjustment deterioration, loose brick and infiltration.

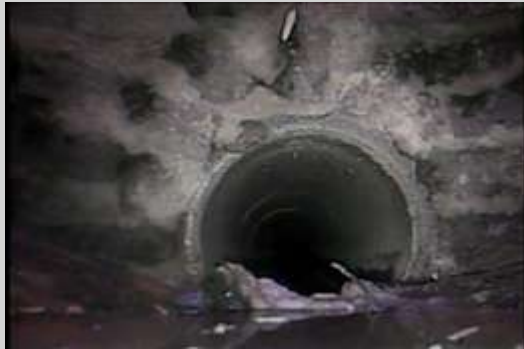
8 in. Circular Gravity Sewer Pipe Out @ 12 O'Clock

Barrel infiltration.

Deposits: ☐ None ☐ Mud ☐ Sludge ☒ Debris ☐ Grease

Silt Depth: **1** (in.) Deposits Extent: **Light**

Infiltration: **Evidence** Pipe Seal Cond: **Unknown**

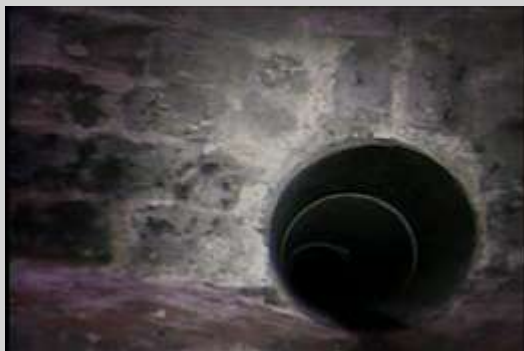
8 in. Circular Gravity Sewer Pipe Out @ 6 O'Clock

Infiltration: **Evidence** Pipe Seal Cond: **Unknown**
